Vapor Intrusion Assessment 825 Stewart Drive, Sunnyvale

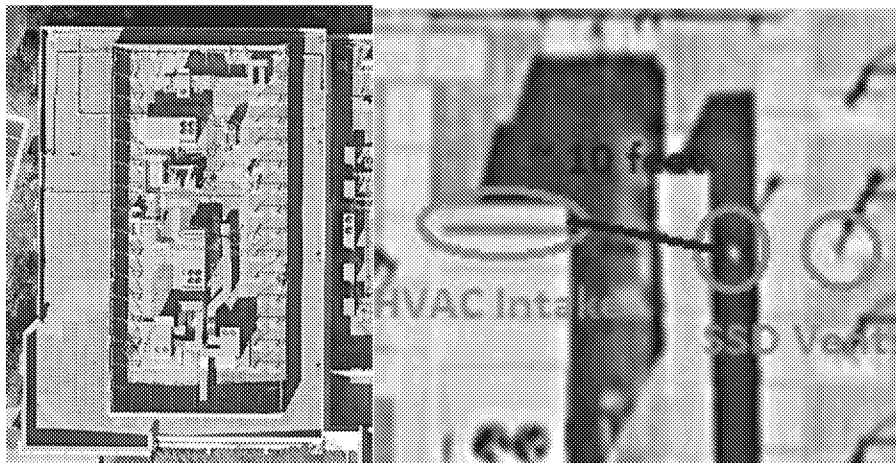
- Significant, visible slab cracks, gaps and penetrations had been sealed.
- There was positive pressure between the lobby and outside of approximately 1.5 pascal during the visit.
- The elevator pit and penetrations appear to be sealed from the subsurface. The elevator is a typical piston type low rise elevator. The piston housing remains a potential pathway for vapor entry, as it penetrates deep into the subsurface (typically these are twenty feet or more deep).
- The SSD vents on the roof are not significantly elevated above the roof (~ 3 feet) and are sheltered from wind.
- A main HVAC intake is approximately 10-feet from the western SSD vent. It is recommended that the vent stacks be reconfigured to avoid vapor intake from the HVAC.

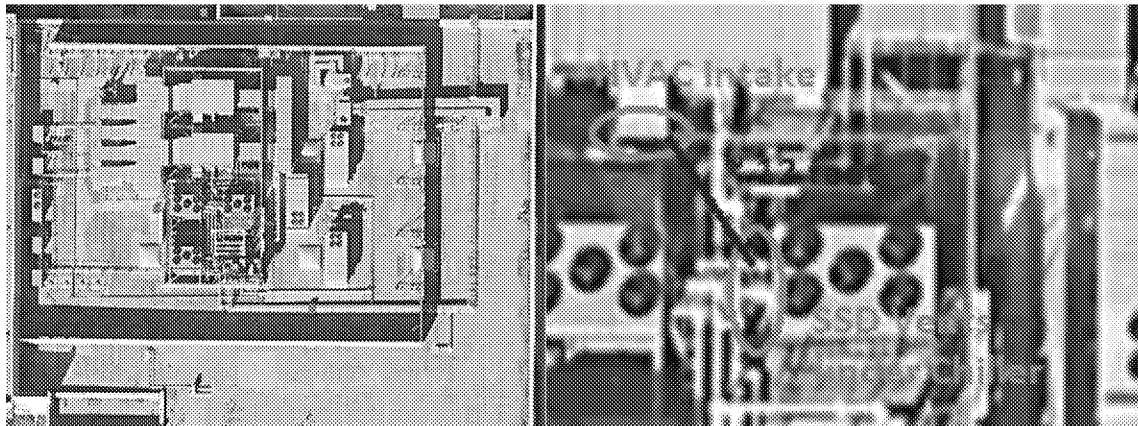
- The SSD vents on the roof are under the building chiller plant piping and are within 12-feet of a ventilation system intake. There is not significant air flow near the SSD vent stacks and it is likely that the SSD vents are not functioning as intended and vapors could be building up on the roof near the HVAC intake.

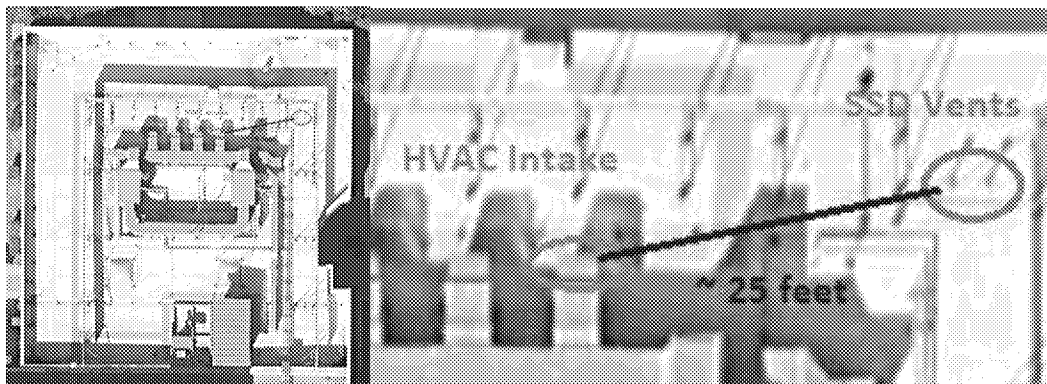
- There was positive pressure between the rear hall and the outside of 4 pascals.
- Several subslab ports could not be located.
- The SSD vents on the roof are approximately 25 feet from the nearest HVAC intake and they were relatively unobstructed by HVAC and roof structures.
